ANALYSIS OF CALCULATED AND OBSERVED SETTLEMENTS OF THE SILO ON LOESS

Subject review

Keywords: foundation; hydro-collapse; loess; settlement

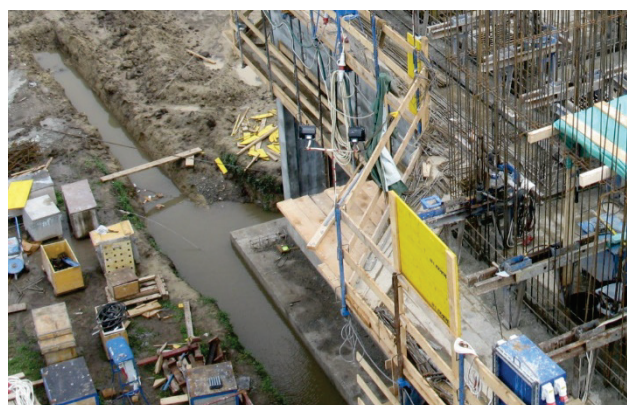
Figure 1 Heavy saturation of the foundation pit

Construction of the building began in late March 2010. During and after the excavation of the foundation pit, weather conditions were very unfavourable with a very large amount of rainfall resulting in difficult construction conditions. It should be noted, that the foundation pit, especially for the silo, was open and unprotected for a long period of time. The water infiltration was further facilitated through gravel-sand cushion, so in a short time the base of the pit had water

several decimetres deep. The volume of flooding is shown in Figs. 1 and 2. This event reoccurred at the beginning of July. With few exceptions, water was always present in the foundation pit.

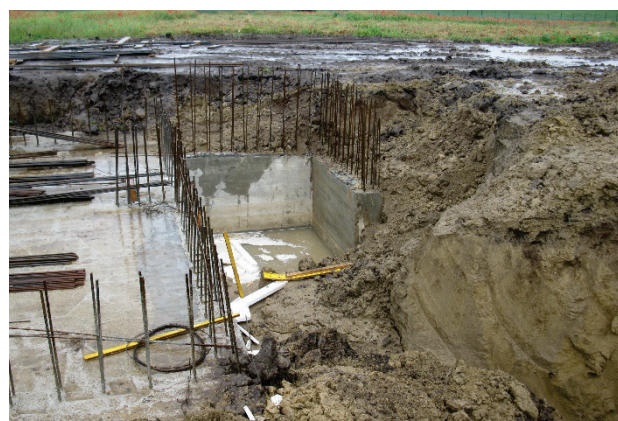
Figure 2 Saturation and sliding ground around the foundation pit
